MINUTES OF PUBLIC INFRASTRUCTURE COMMITTEE

Held on Thursday 10 March 2022

10.1 January 2022 Monthly Report

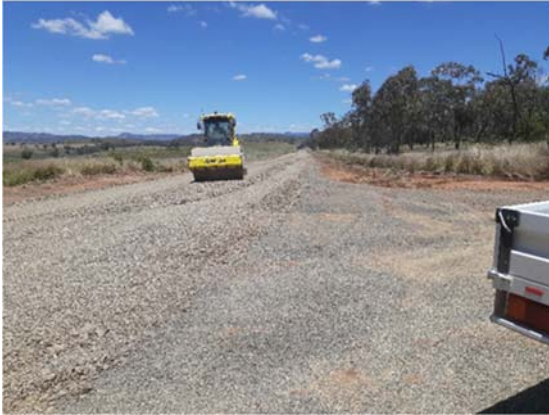
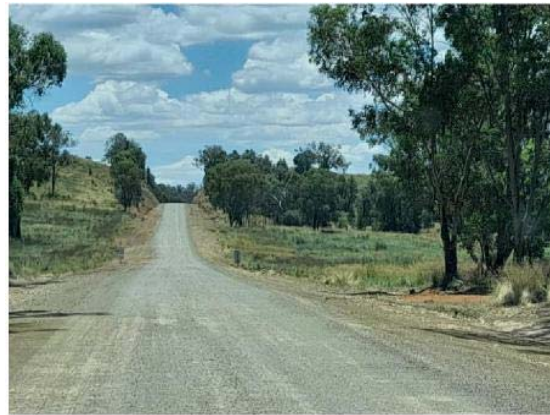
Works on SR11 Horton Road Upgrade.

Southern construction staff continue working on the SR11 Horton Road Upgrade, currently final trimming the second stage of the project, after stabilizing the 200mm base layer with a slag/lime blend. This section was bitumen sealed in February, resulting in a total of over 6km (of 16km total) sealed). With drainage works completed well ahead of the construction crew, staff continue with construction of the next 3km section.

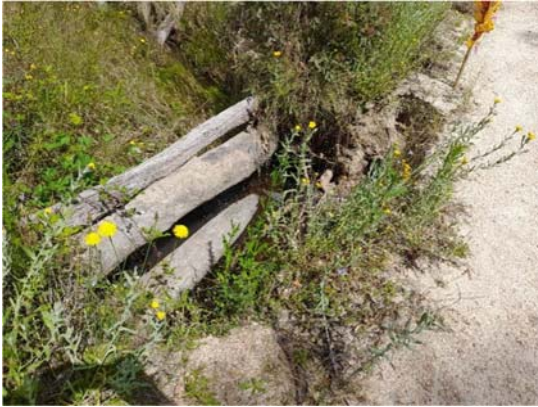
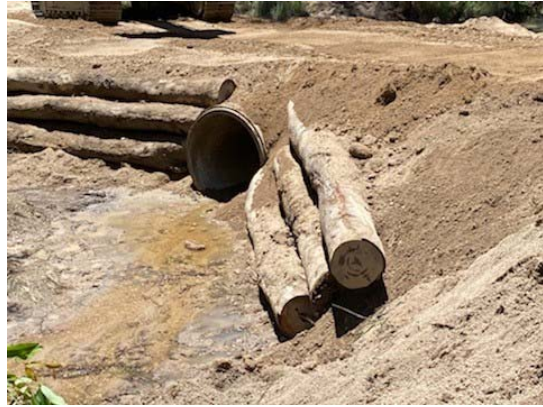
Before and after photographs of the failed bridge at 1964 Bingara Road, Bundara.

Staff have also completed works removing a failed timber bridge at 1964 Bingara Road, Bundarra, replacing it with a large concrete pipe culvert to provide access for the residents.

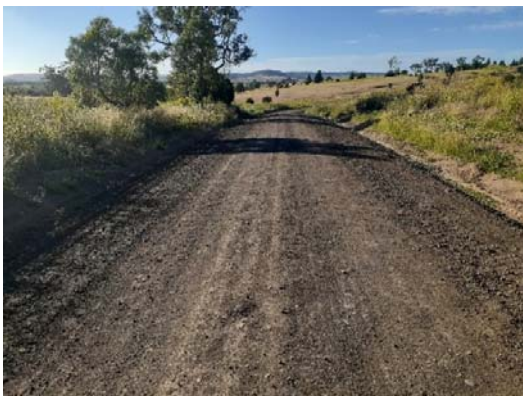
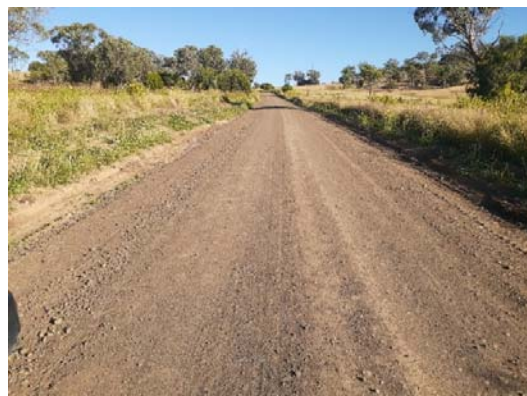
Gravel resheeting on SR67 Agincourt Road.

Gravel resheeting works (not including flood damage) have been carried out on a 12km section of SR62 Hibernia Road as well as sections of SR67 Agincourt Road, SR64 Gournama Road and SR54 Pinecliff Road. Flood damage works have also seen further gravel resheeting on SR67 Agincourt Road, SR64 Gournama Road, SR54 Pinecliff Road, SR60 Pound Creek Road and SR45 Berreen Road.

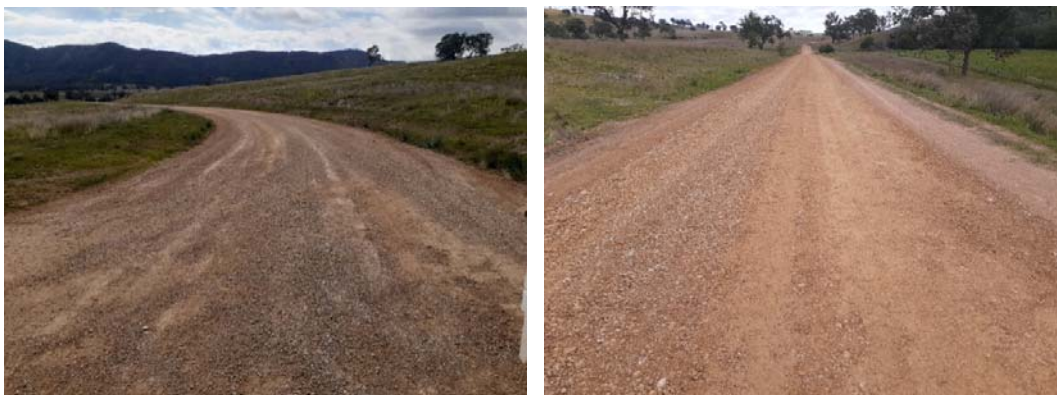
Gravel resheeting on SR54 Pinecliff Road.

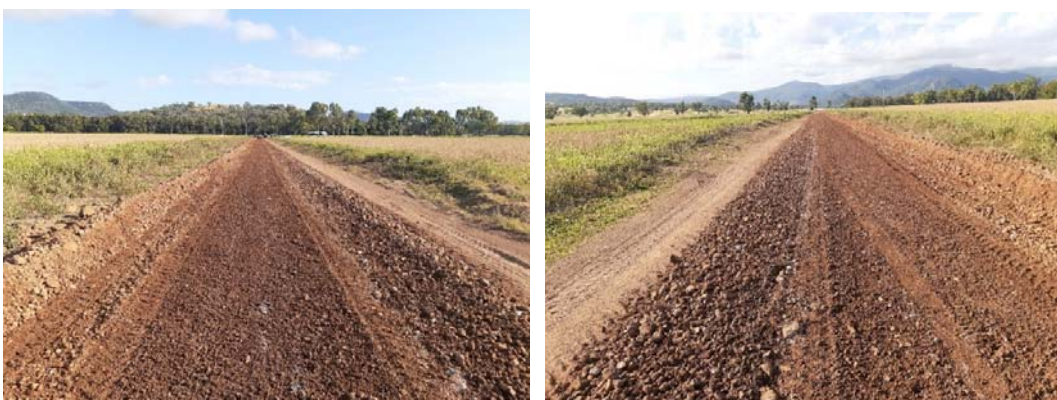
Gravel resheeting on SR60 Pound Creek Road.

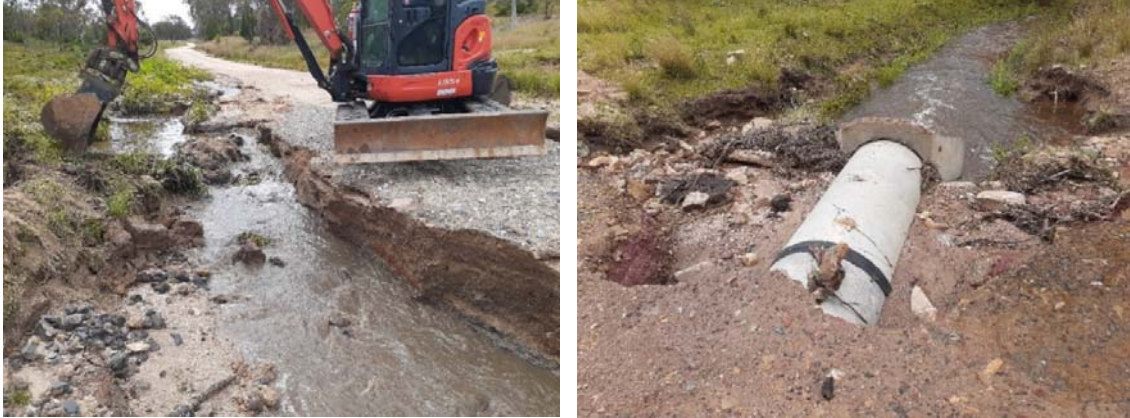
Emergent works undertaken on SR23 Wearnes Road.

Staff are continuing to repair and collect damages on several roads after the storm event on the 9th November 2021. Temporary pipes have been installed on severe scours across SR23 Wearnes Road as emergent works, that will be removed when the flood damage work begins.

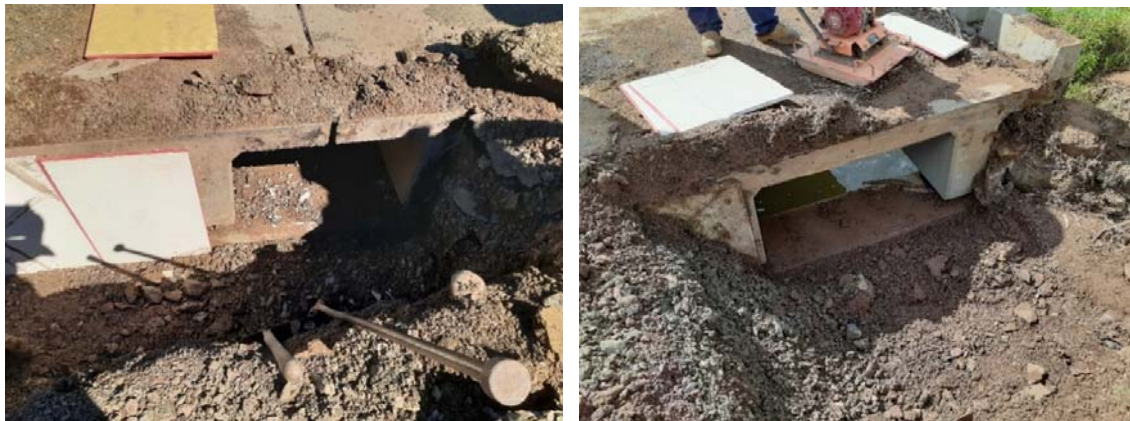
Emergent work on the approaches to the Rocky Creek bridge on MR133 Killarney Gap Road has now been completed. The bridge abutment retaining boards were damaged after the flooding of Rocky Creek during the November storms. Heavy patching and sealing of the approaches to the bridge and other causeways on MR133 Killarney Gap Road will commence in coming months.

Rocky Creek bridge on MR133 Killarney Gap Road.

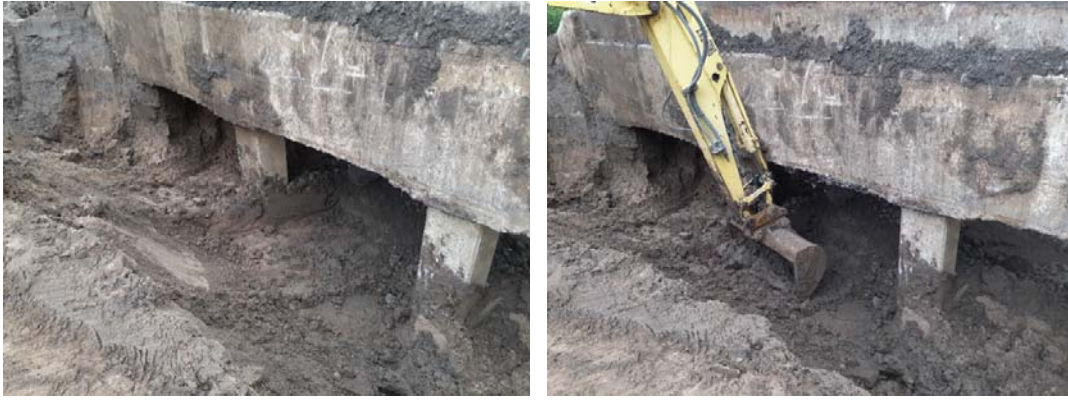
Repairs undertaken on SR14 Mosquito Creek Road bridge.

The approaches to the bridge over Mosquito Creek on SR14 Mosquito Creek Road have also been repaired under emergent works, carried out by Johnstone Concrete and Quarries.

The western approach was excavated to just below the water level and replaced with large shot rock and concrete.

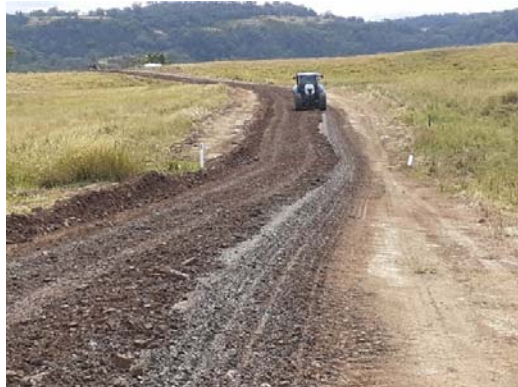
Flood damage works on SR45 Bereen Road.

The southern flood damage crew have now commenced works, gravel resheeting sections of SR45 Bereen Road.

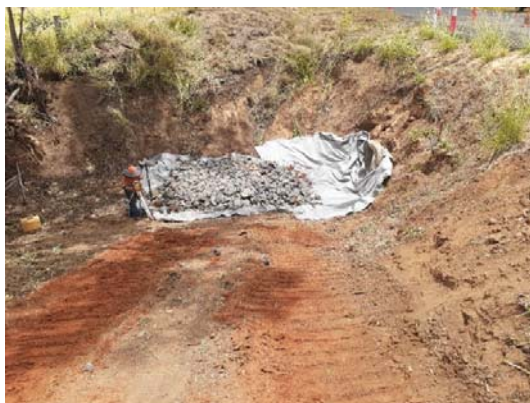
Pipe culvert works on SR13 Oregon Road.

DP Earthmoving have been engaged to replace a concrete pipe culvert 12km west of Warialda on SR13 Oregon Road which was damaged during the March flood event. Based out of Grafton, they have been completing work in the area with favorable comments from neighboring clients.

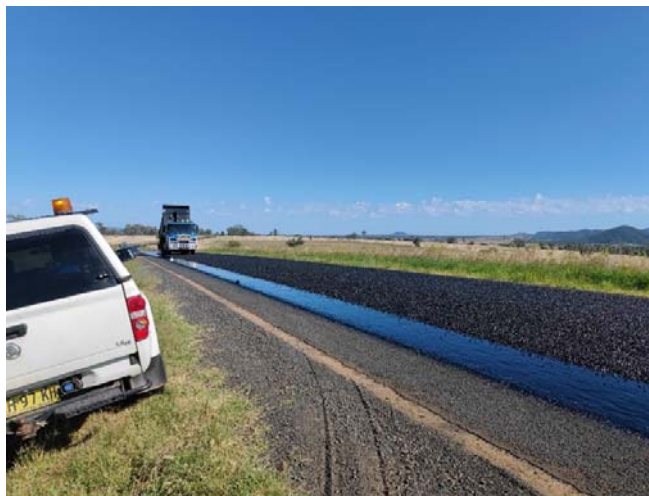
Fulton Hogan resealing on MR63 Fossickers Way.
