PUBLIC INFRASTRUCTURE COMMITTEE

AGENDA

10.1 January 2022 Monthly Report

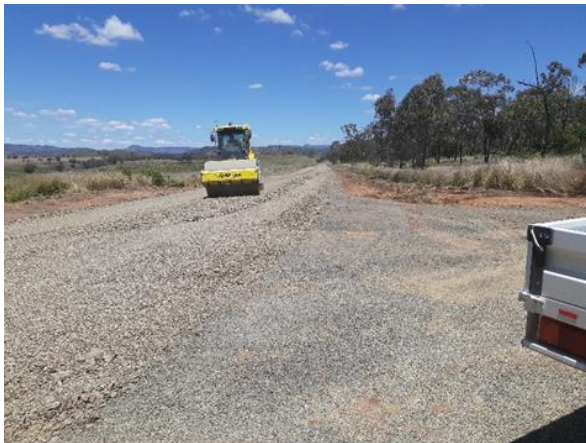
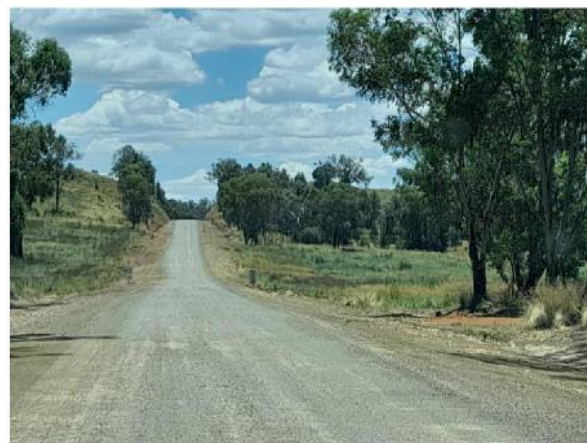
Works on SR11 Horton Road Upgrade.

Southern construction staff continue working on the SR11 Horton Road Upgrade, currently final trimming the second stage of the project, after stabilizing the 200mm base layer with a slag/lime blend. This section was bitumen sealed in February, resulting in a total of over 6km (of 16km total) sealed). With drainage works completed well ahead of the construction crew, staff continue with construction of the next 3km section.

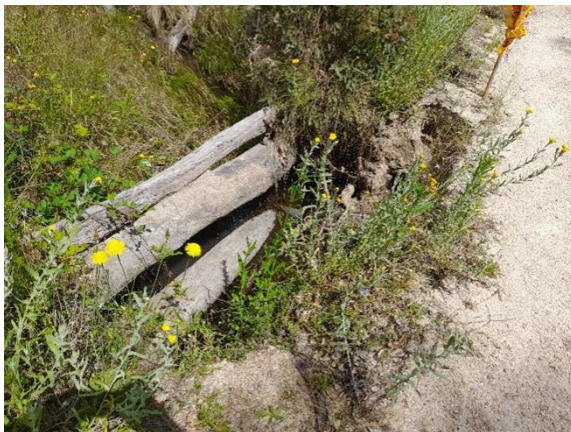
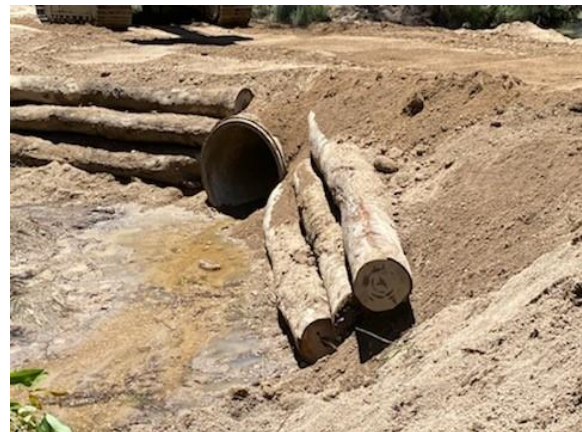
Before and after photographs of the failed bridge at 1964 Bingara Road, Bundarra.

Staff have also completed works removing a failed timber bridge at 1964 Bingara Road, Bundarra, replacing it with a large concrete pipe culvert to provide access for the residents.

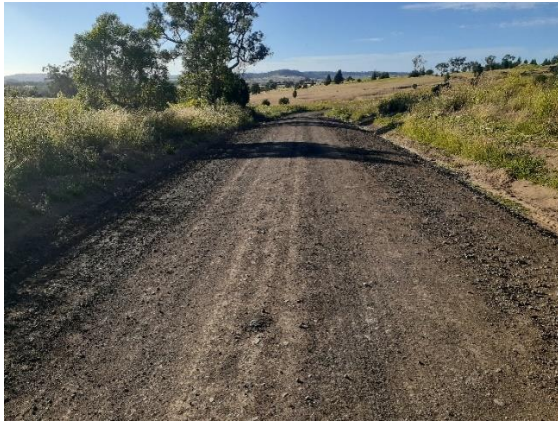
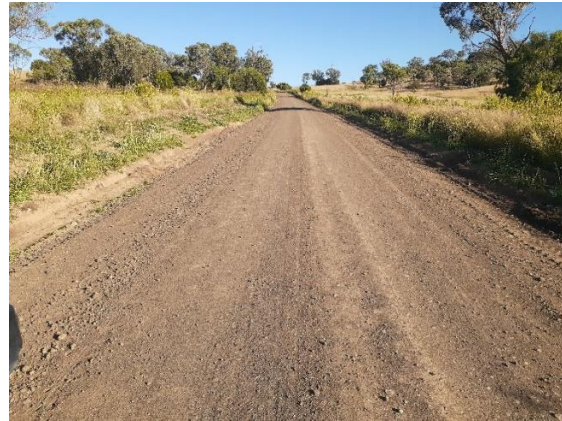
Gravel resheeting on SR67 Agincourt Road.

Gravel resheeting works (not including flood damage) have been carried out on a 12km section of SR62 Hibernia Road as well as sections of SR67 Agincourt Road, SR64 Gournama Road and SR54 Pinecliff Road. Flood damage works have also seen further gravel resheeting on SR67 Agincourt Road, SR64 Gournama Road, SR54 Pinecliff Road, SR60 Pound Creek Road and SR45 Berreen Road.

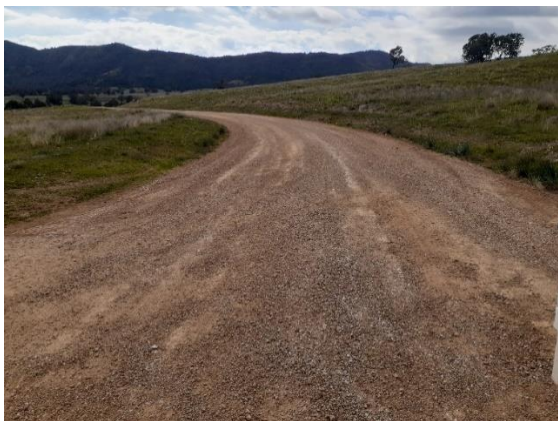
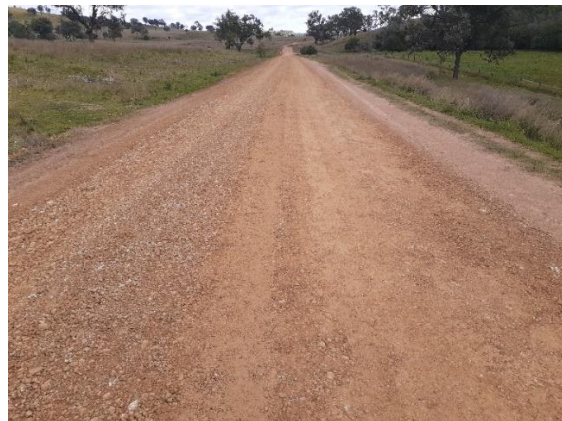
Gravel resheeting on SR54 Pinecliff Road.

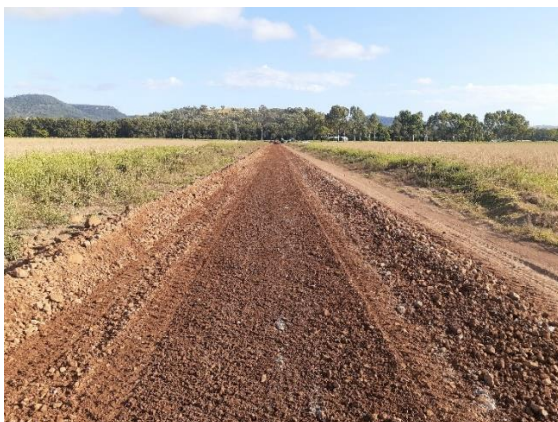
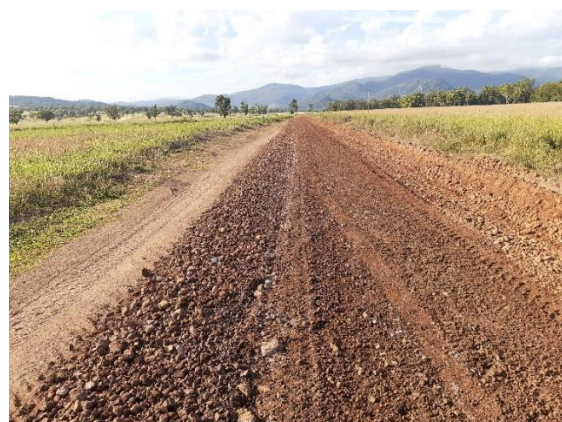
Gravel resheeting on SR60 Pound Creek Road.

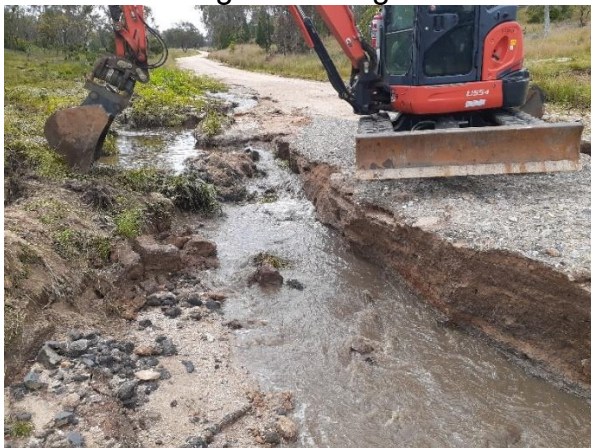
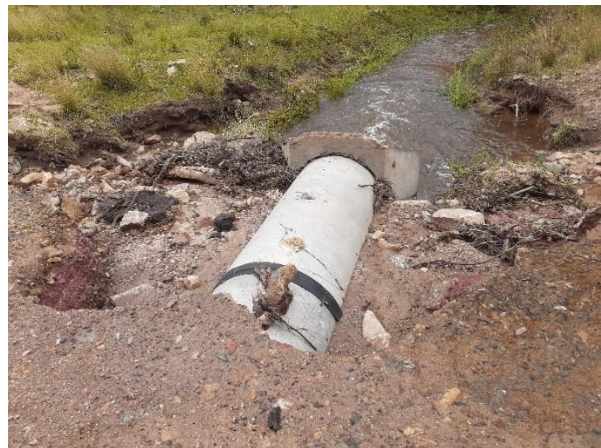
Emergent works undertaken on SR23 Wearnes Road.

Staff are continuing to repair and collect damages on several roads after the storm event on the 9th November 2021. Temporary pipes have been installed on severe scours across SR23 Wearnes Road as emergent works, that will be removed when the flood damage work begins.

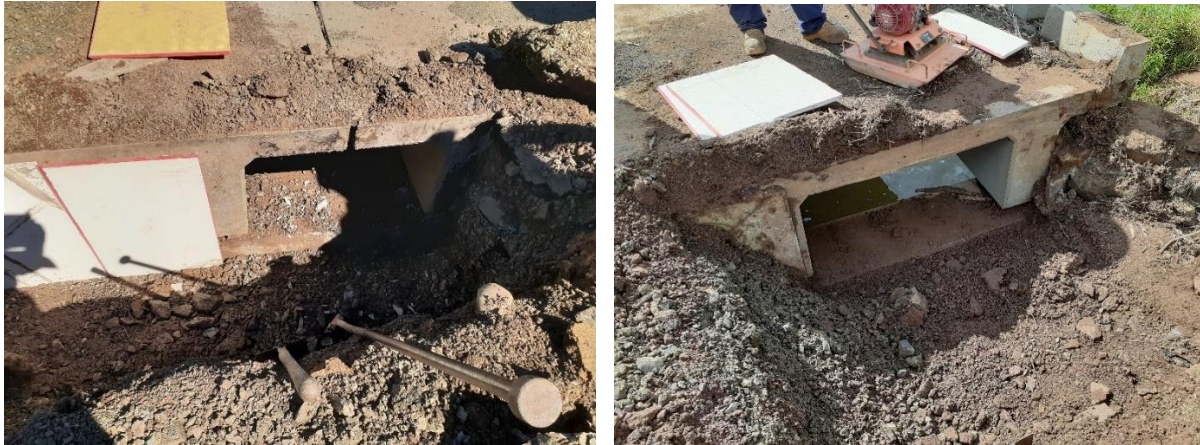
Emergent work on the approaches to the Rocky Creek bridge on MR133 Killarney Gap Road has now been completed. The bridge abutment retaining boards were damaged after the flooding of Rocky Creek during the November storms. Heavy patching and sealing of the approaches to the bridge and other causeways on MR133 Killarney Gap Road will commence in coming months.

Rocky Creek bridge on MR133 Killarney Gap Road.

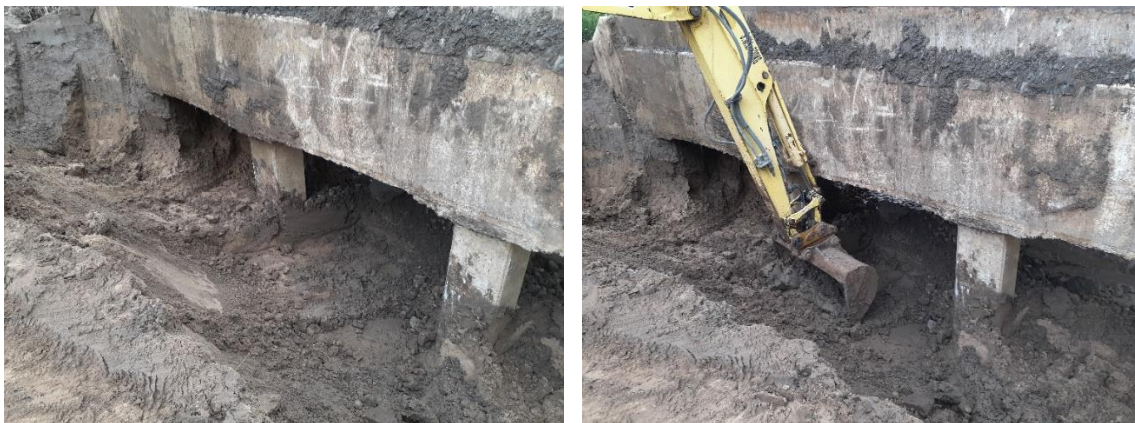
Repairs undertaken on SR14 Mosquito Creek Road bridge.

The approaches to the bridge over Mosquito Creek on SR14 Mosquito Creek Road have also been repaired under emergent works, carried out by Johnstone Concrete and Quarries.

The western approach was excavated to just below the water level and replaced with large shot rock and concrete.

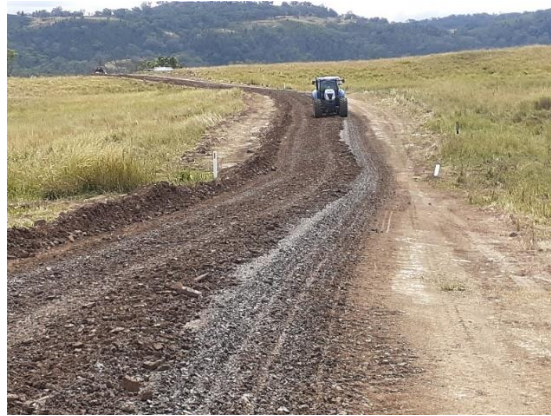
Flood damage works on SR45 Breen Road.

The southern flood damage crew have now commenced works, gravel resheeting sections of SR45 Bereen Road.

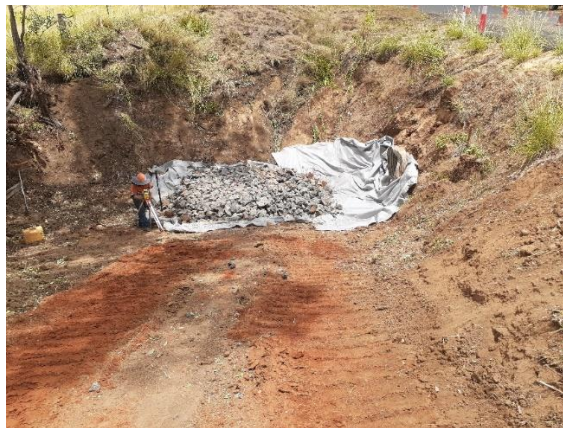
Pipe culvert works on SR13 Oregon Road.

DP Earthmoving have been engaged to replace a concrete pipe culvert 12km west of Warialda on SR13 Oregon Road which was damaged during the March flood event. Based out of Grafton, they have been completing work in the area with favorable comments from neighboring clients.

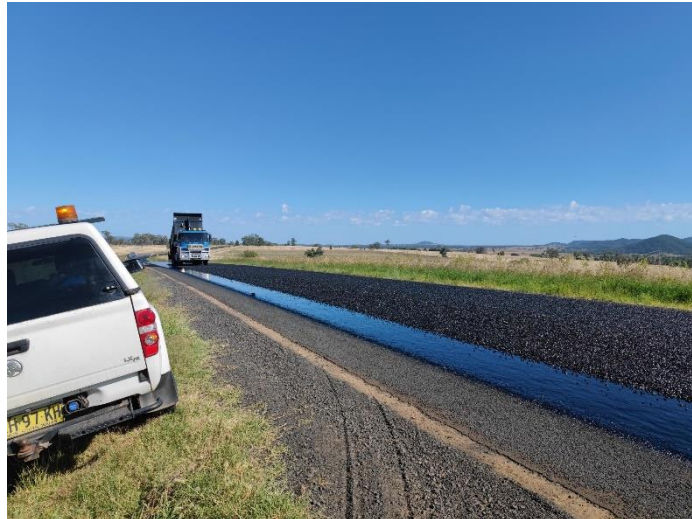
Fulton Hogan resealing on MR63 Fossickers Way.
